Appendix E2a.ii (2) – Restoration Plans and TMDLs (Restoration Inspections)

STORM WATER MANAGEMENT INSPECTION REPORT

Project: Anita C. Leight Estuary Center Micro-bioretenion 1
Site Address: 618 Otter Point Rd, Abingdon, MD 21009

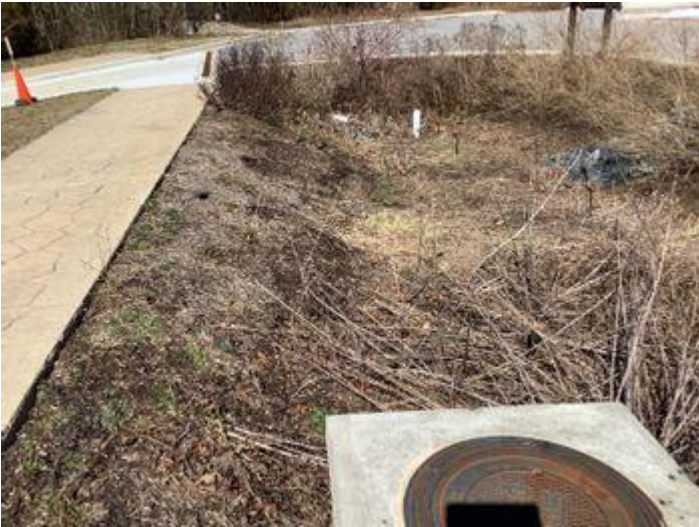
Photo 3

Mulch is eroding along slopes.

Description
Mulch eroding; restore as per plan

Re-mulch as per plan.

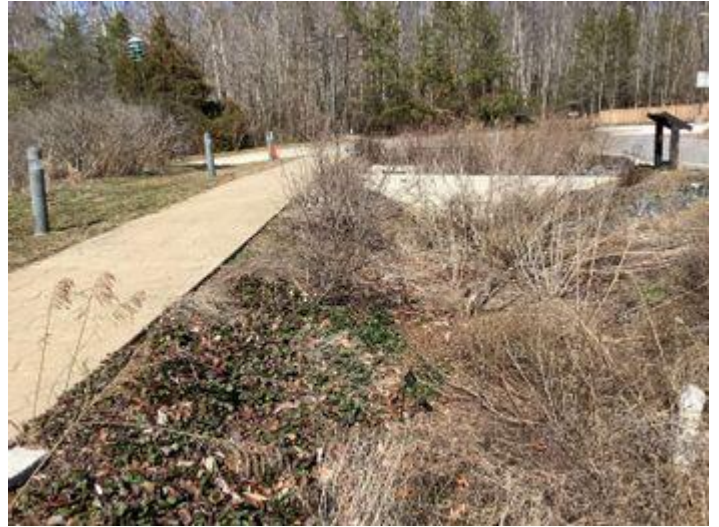
Photo 2

Mulch appears to be eroding along slopes.

Mulch eroding along slopes

Restore as per plan; refurbish mulch as needed.

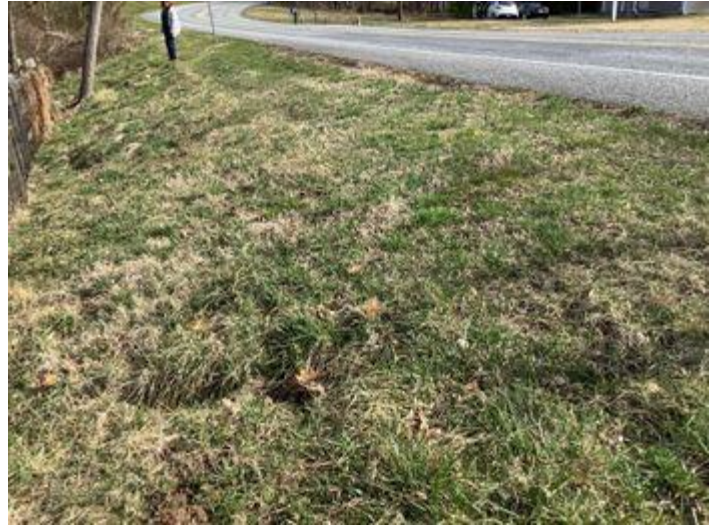
Photo 2

Description
Erosion from Wheel Rd

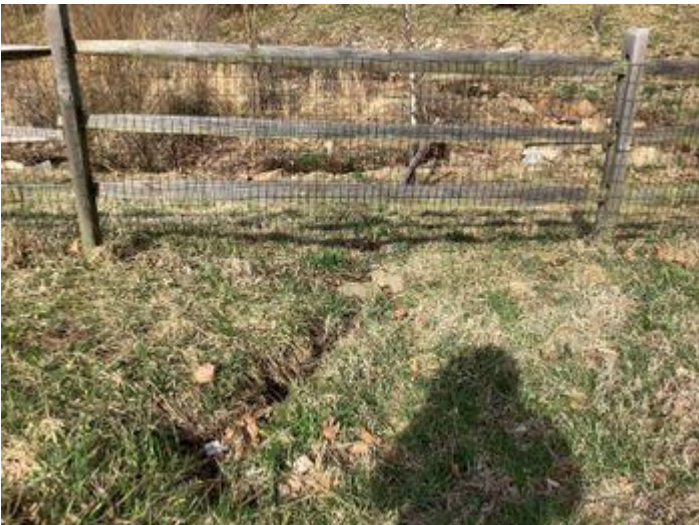
Photo 3

Description
Erosion

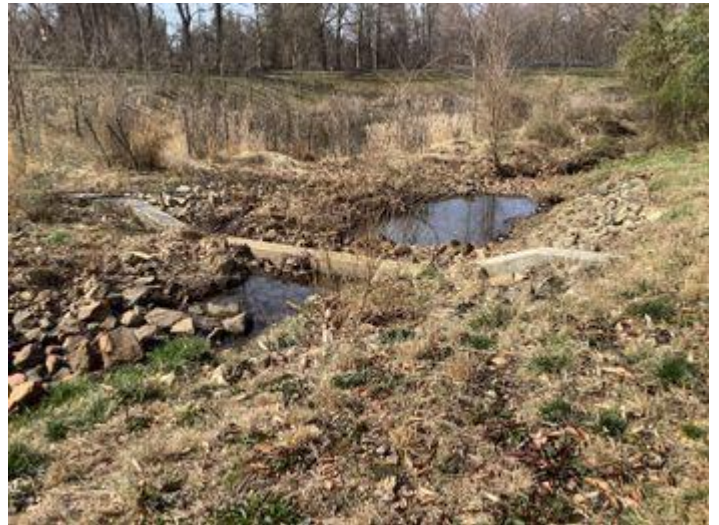
Photo 4

Description
Concrete check dam; orifice plate clogged

Repair the riser and remove debris from the orifice plate.
Remove vegetation from the channel and unclog the dewatering pipe.

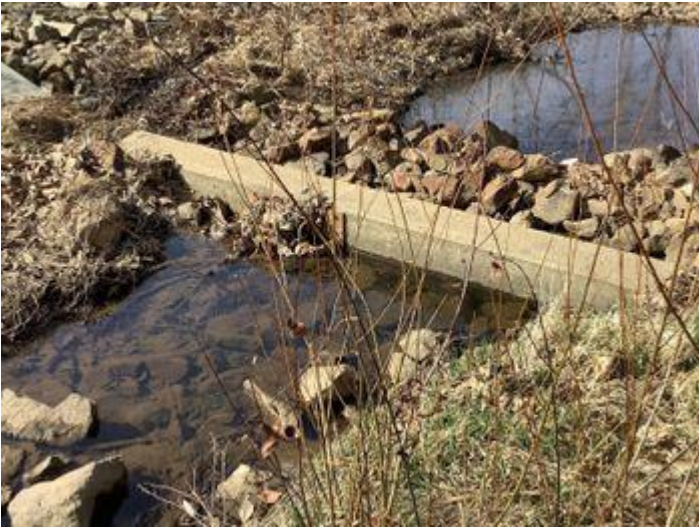
Photo 5

Description
Closeup of orifice

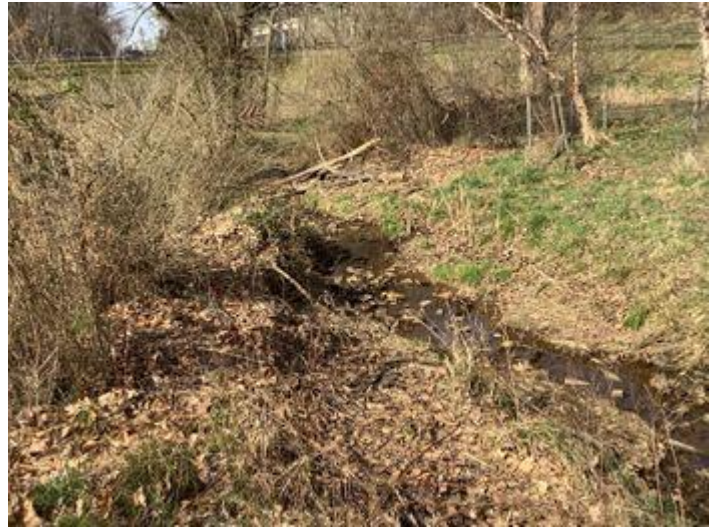
Photo 6

Description
Fallen vegetation in channel

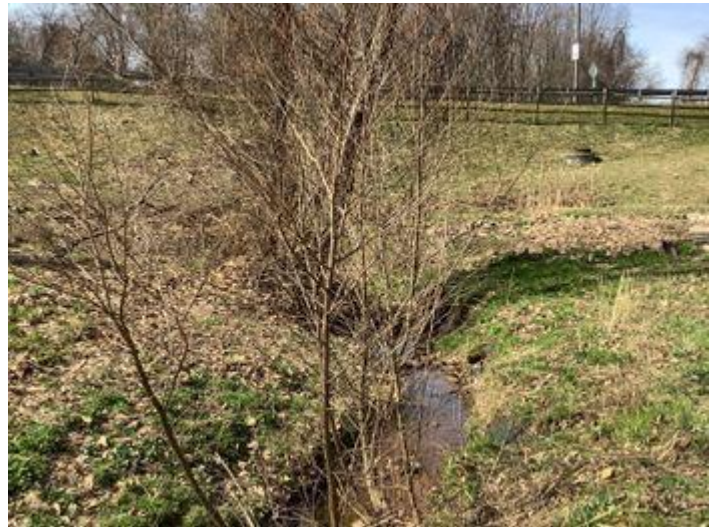
Photo 8

Description
Volunteer growth restricting channel flow; remove

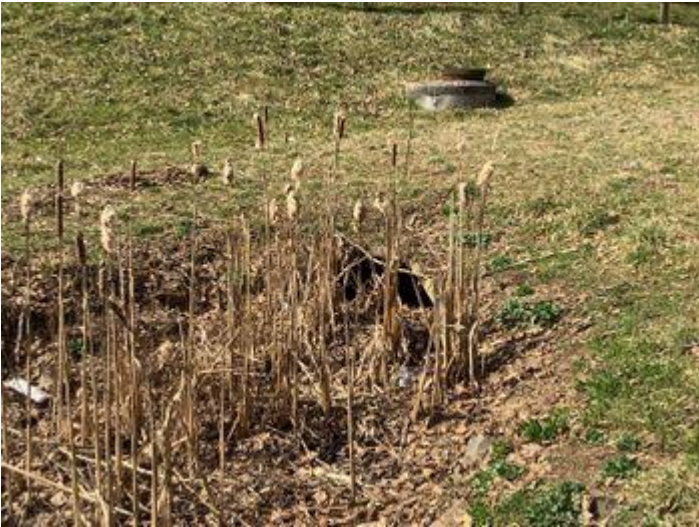
Photo 9

Stormdrain outfall obstructed with vegetation

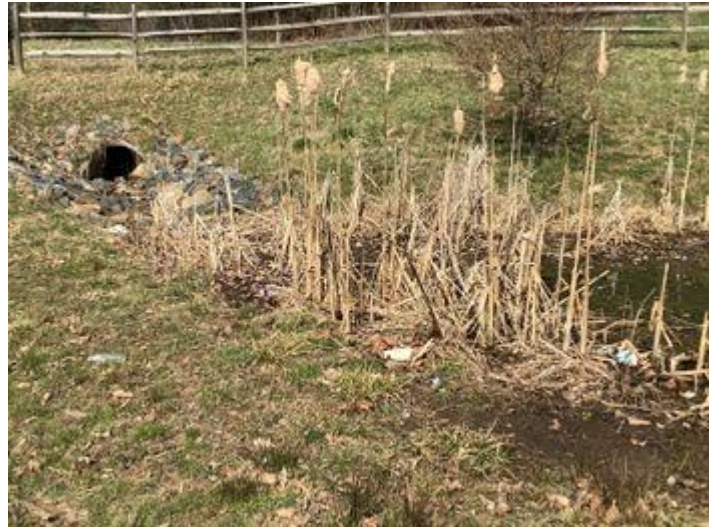
Photo 10

Inflow ; trash

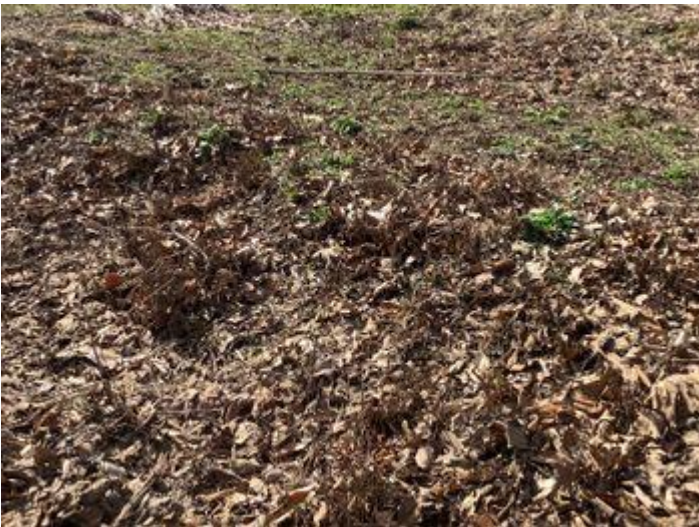
Photo 11

Low flow choked

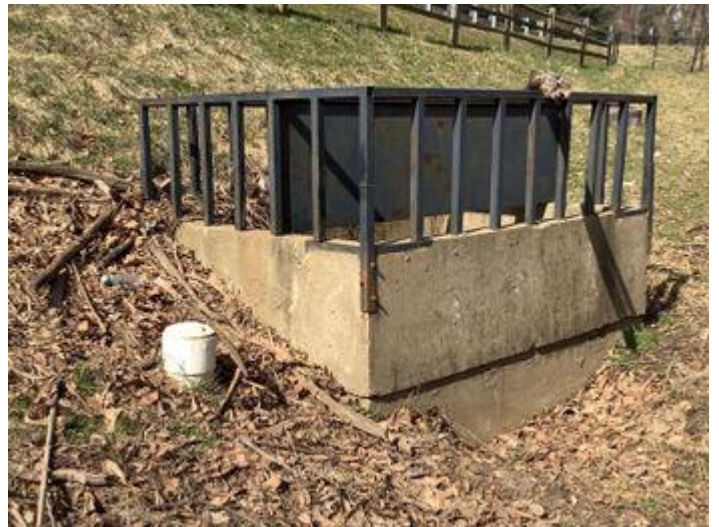
Photo 12

There is seepage into the riser; check dam orifice plate clogged; fallen vegetation in channel; outflow pipe has rusted through; perforated pipe clogged

Riser debris; depression in front

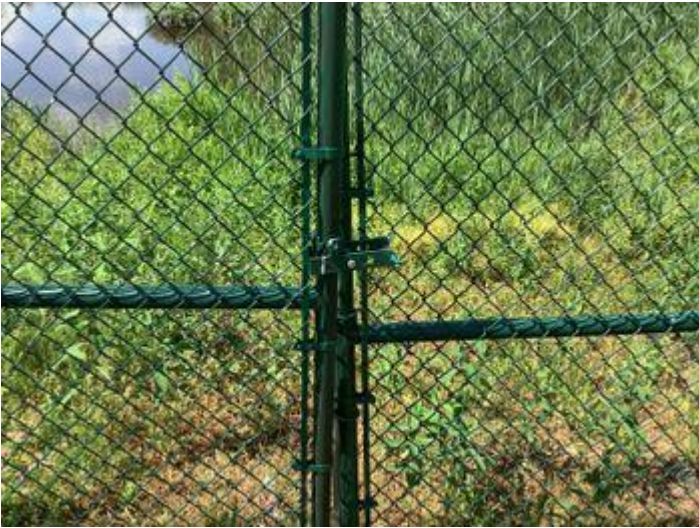
Photo 3

Facility is completely overgrown. Could not inspect all elements of the pond. The gate was misaligned.

Misaligned gate

Clear out the pond to make all elements accessible for reinspection. Align the gate.

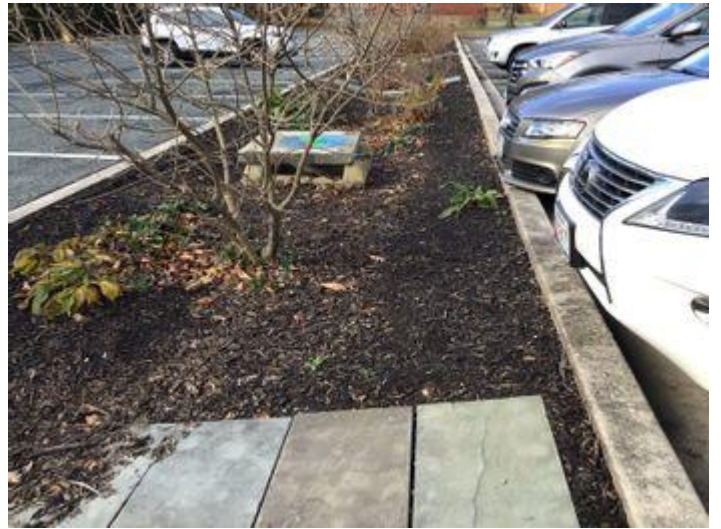
Photo 2

Top of control structure has shifted from pedestal

Comments/Corrections:
Realign the top of the control structure.
Remove leaf debris from median.
Loosen the surface of mulch.

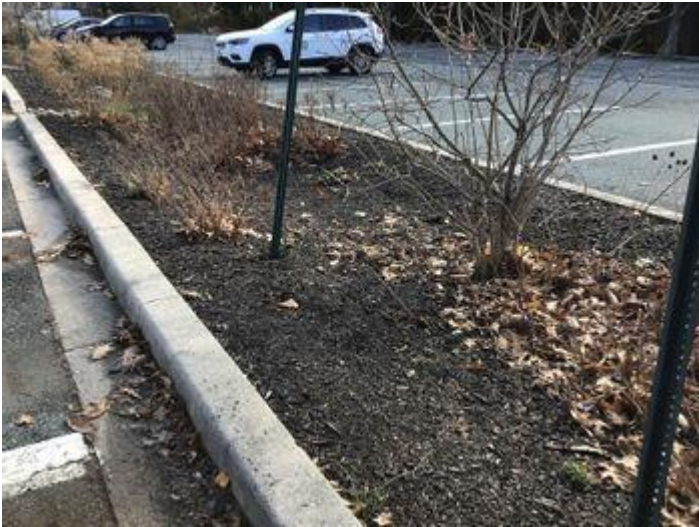
Photo 3

Leaf accumulation

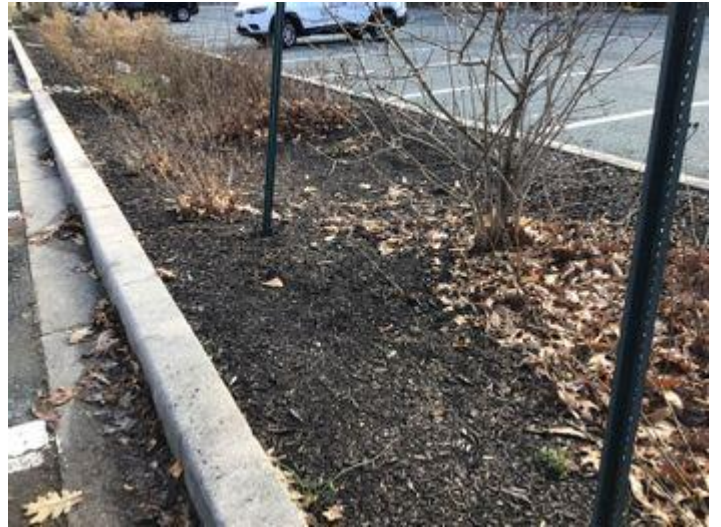
Photo 4

Mulch is packed tight on the surface

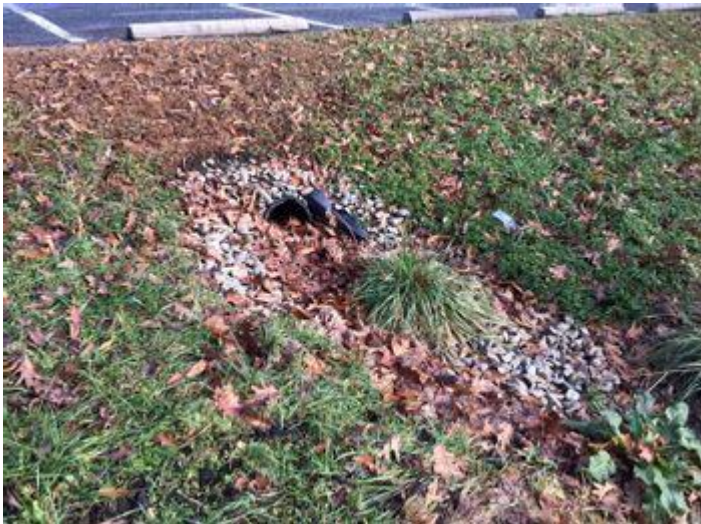
Photo 3

Overall Notes:
No sheet flow from parking lot; sediment and vegetation obstructing flow.
Hard packed surface and scarce plantings.
HDPE outfall obstructed by vegetation and leaves.
Control box -weir elevation is equal to bottom elevation.

HDPE pipe

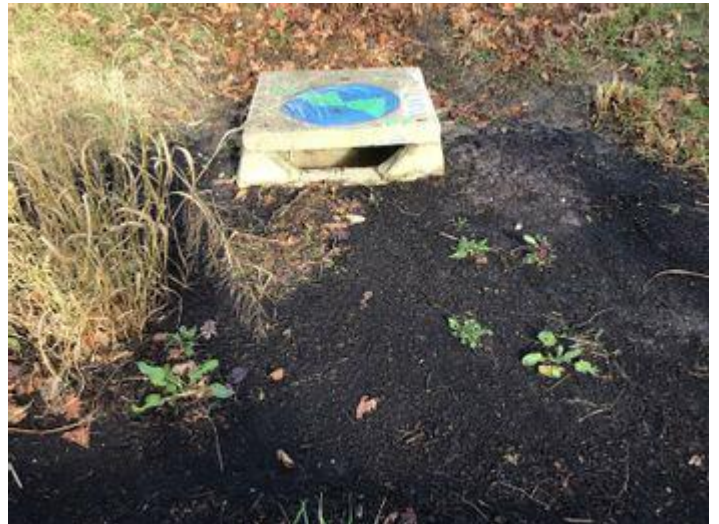
Photo 4

Control box no storage

Comments/Corrections
Provide sheet flow into the facility.
Scarify surface and apply fresh mulch.
Install plantings as per plan.
Check the plans for correct weir elevations.

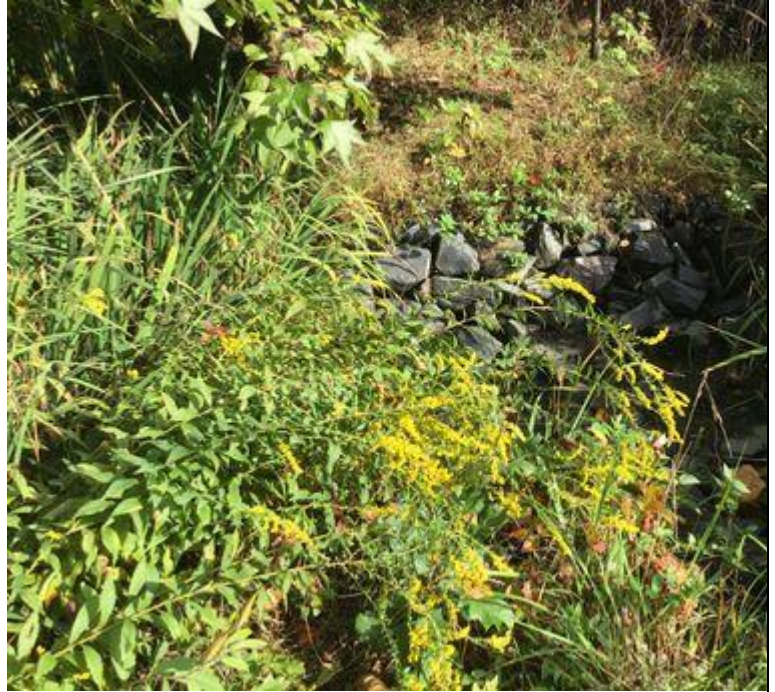
Photo 2

Spillway is restricted by tall vegetation.

Description
View of stone spillway

Cut the vegetation on both sides of the stone spillway.

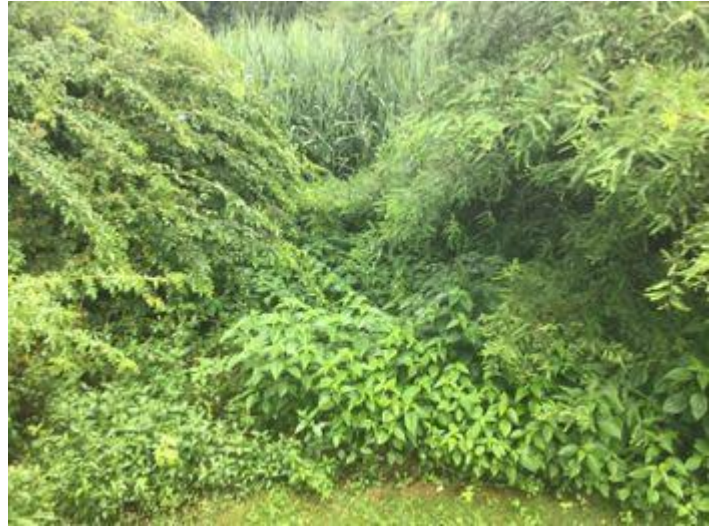
Photo 2

Description
Stormdrain outfall overgrown

Remove the debris and vegetation within 25 feet of the riser.
Remove the vegetation from the emergency spillway.
Remove the vegetation from the stormdrain outfall.
The principal spillway outfall pipe must be replaced.

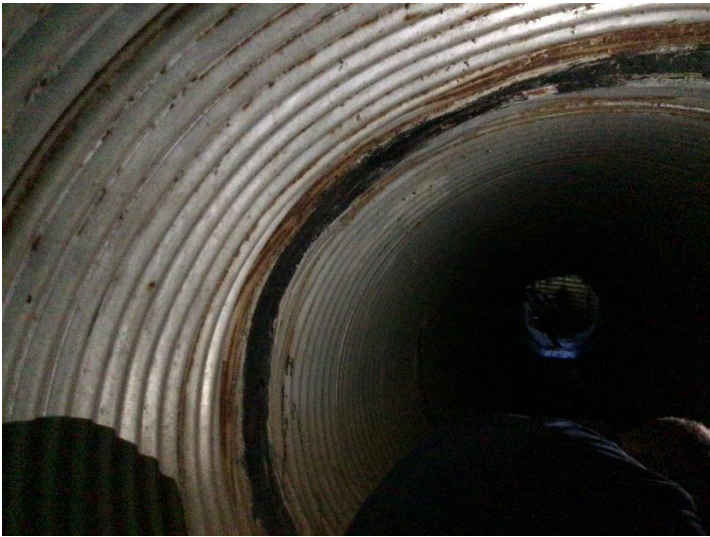
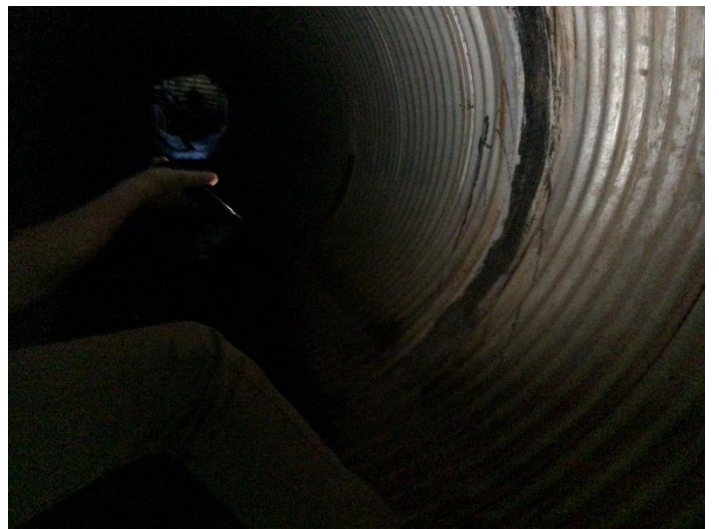
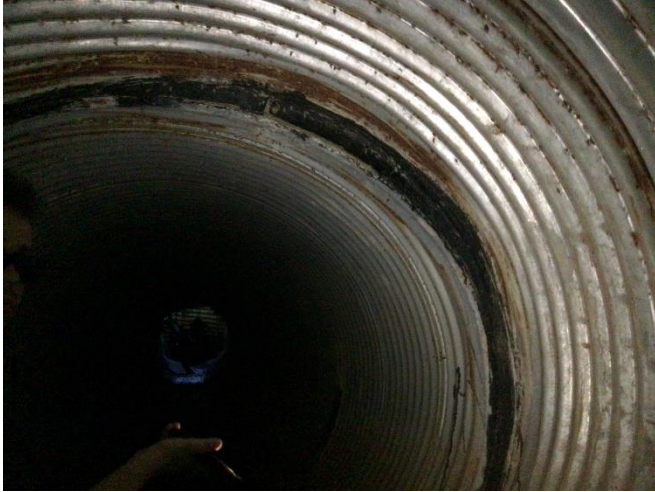
There is debris and vegetation around the riser.
There is vegetation in the emergency spillway.
The stormdrain outfall is overgrown.
The principal spillway outfall pipe is damaged.

Inside of the Principal spillway outfall pipe

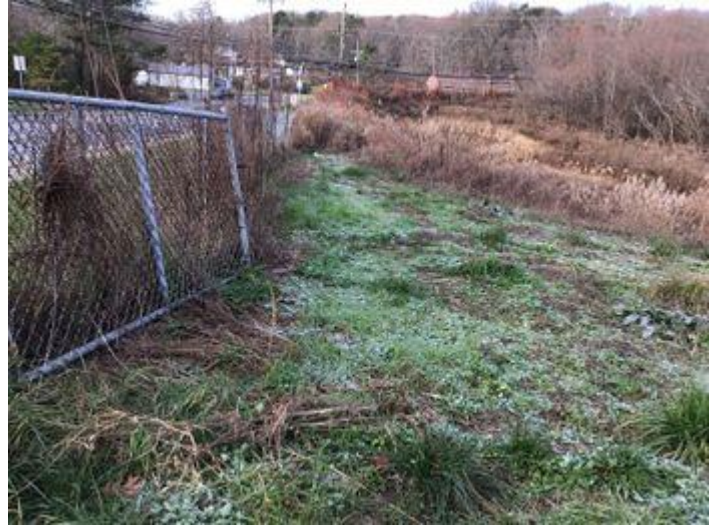
Photo 2

Description
Upstream dam slope

Remove woody vegetation from the dam and fence.

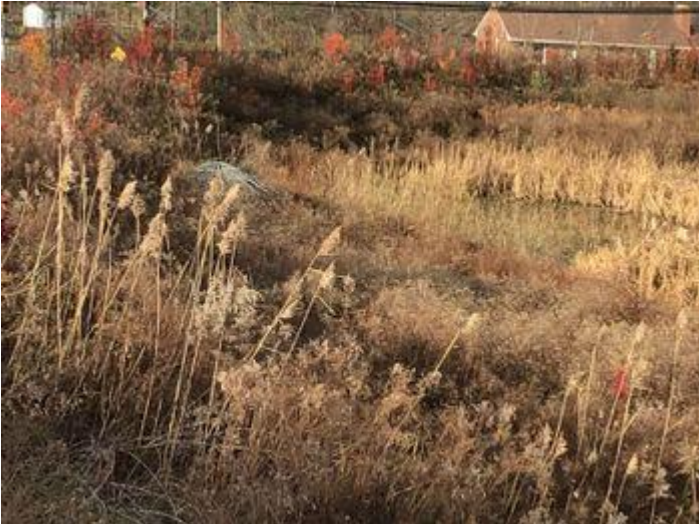
Photo 3

Woody vegetation on upstream dam slope and fence and within the riser's perimeter. The pilot channel is overgrown overgrown.
Incomplete inspection due to overgrowth.

Description
Riser overgrown
